## m.v. Fulmar S — No. 7 Cargo Hold Damage Repair

Port of Haldia | 26 March 2026 – 29 March 2026 | Deck Ref: 2603 / 1157

CLASS BV APPROVED REPAIR

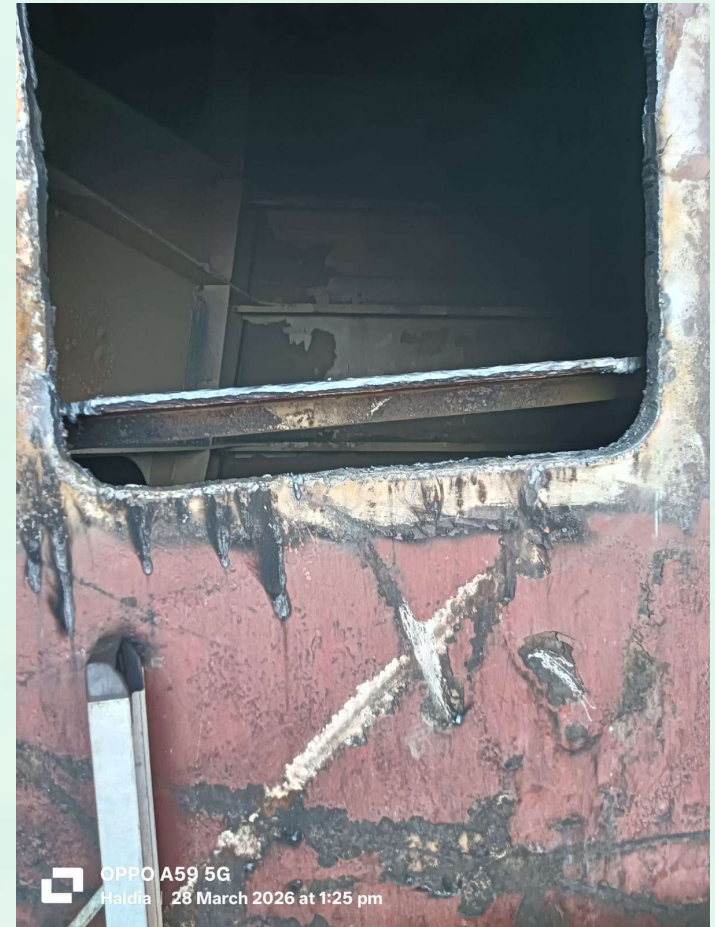
No. 7 Cargo Hold — Between Frame Nos. 44–46 and Hopper Plating Longitudinals 10–11 from Bottom.

Affected area confirmed for full renewal under Bureau Veritas (BV) Class requirements.

Repair scope confirmed as per order from Owners / Managers **Solar Gulf Shipping DMCC**, based on the BV Class Surveyor's inspection report.
