# TMB SHIPPING PVT LTD

## **Various Repair Works done on Pacific International Lines (KOTA Fleet).**

TECHNICAL REPORT

2025-2026

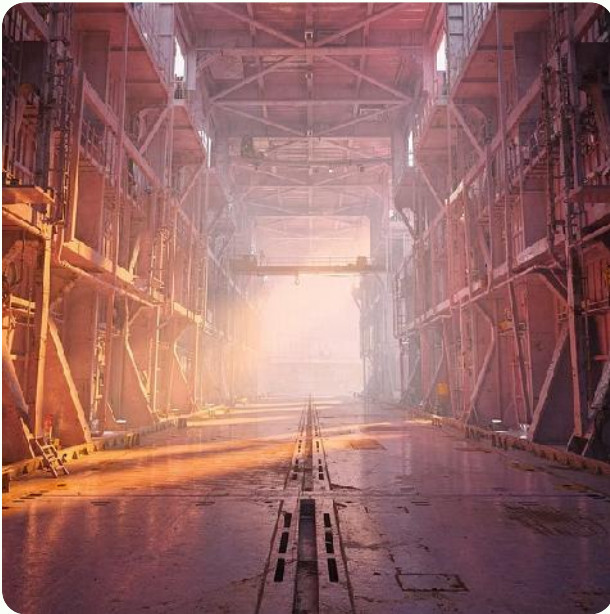
## **m.v. Kota Rakyat**

Bay 06 and Bay 14 cell damaged guides renewed - 7 meters total.  
March 21-23, 2025.

2 nos. / layered staging made around the work area / height using workshop supplied staging materials. The damaged cell guide section gas-cut & removed. New ms angle ( ship-supplied) transferred from Aft. stored area to work position. Same lowered inside cargo-hold taking all safety precautions. The new ms angle guide set/ aligned in position and fitted / welded by multi-run electric welding. All weld deposits cleaned and smoothened by grinding. Ship-supplied ms angle guide 4.5 mtrs. long renewed. After completion, staging removed and the work area cleaned. Balance / leftover angle handed over to vessel.

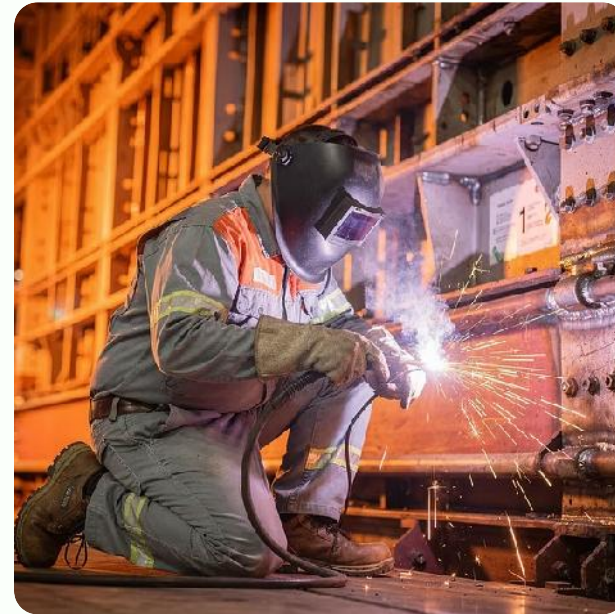
## **m.v. Kota Ratna**

Cell guide repair and renewal at Bay 23 Row 02. August 24-25, 2025.

After completion of the job, it was shown to the Ship staff, found satisfactory. All the stiffeners were painted and the staging was removed from the Cargo Hold and kept in the location given by the Ship staff.

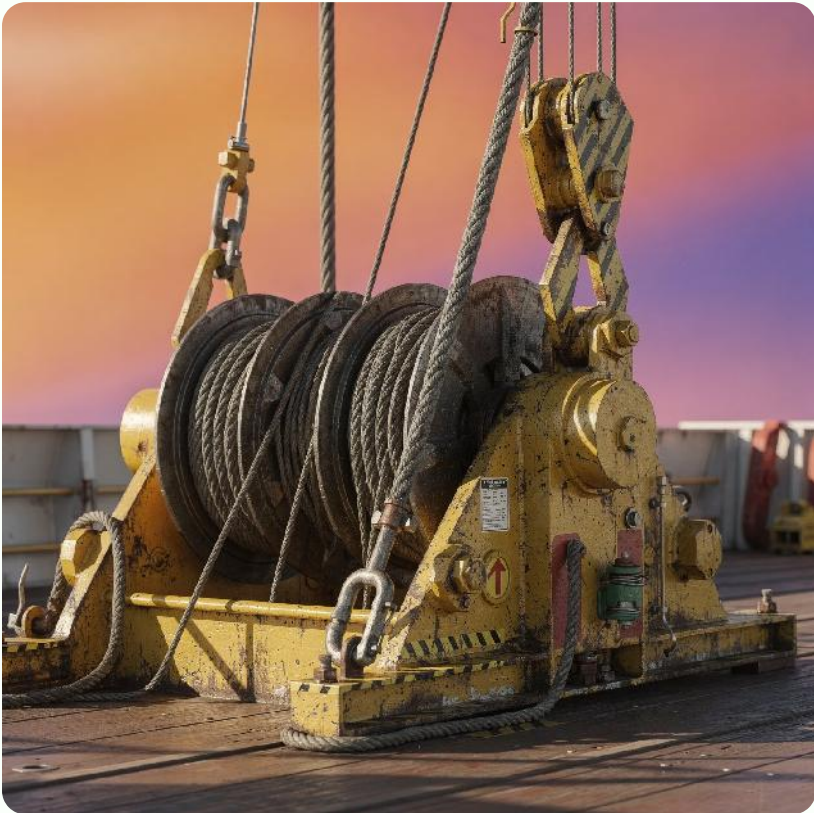
# Deck Crane Runner Wire Sheave Replacement

Emergency repair of No. 2 deck crane runner wire sheave, August 15-16, 2025. Damaged sheave posed significant safety risk to cargo operations and required immediate replacement to restore crane functionality.

Runner wire sheaves are essential for crane operation, guiding wire rope and distributing load forces. Damage can lead to wire rope failure, dropped cargo, and serious accidents.

Replacement completed with precision alignment and thorough testing to ensure safe load-bearing capacity restored.
