# M.V. FENGHAI 66

## Maintenance Report

Comprehensive maintenance operations conducted at NSD, Kolkata during the period of January 7-8, 2026. This report documents critical engine room repairs and system upgrades performed to ensure optimal vessel performance and safety compliance.

# TMB SHIPPING PVT LTD

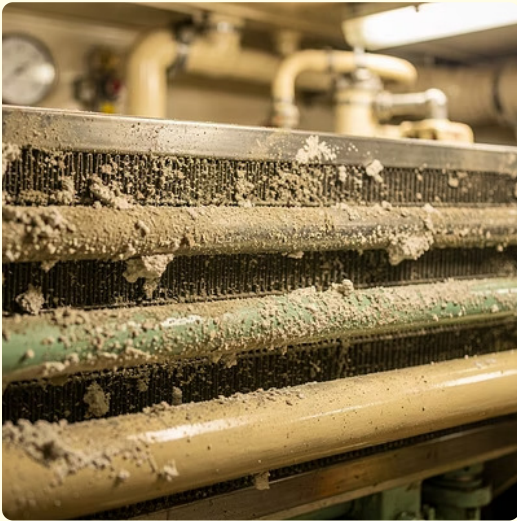
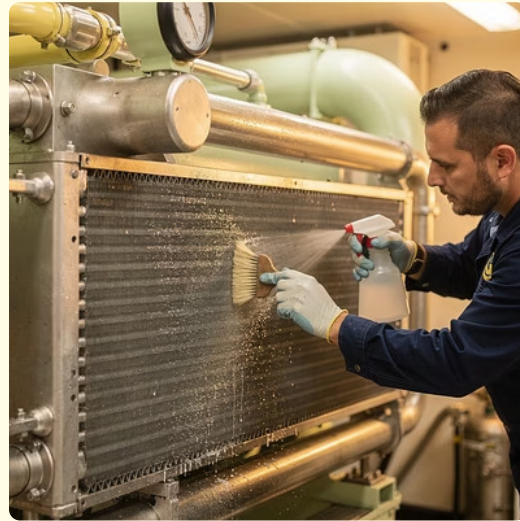
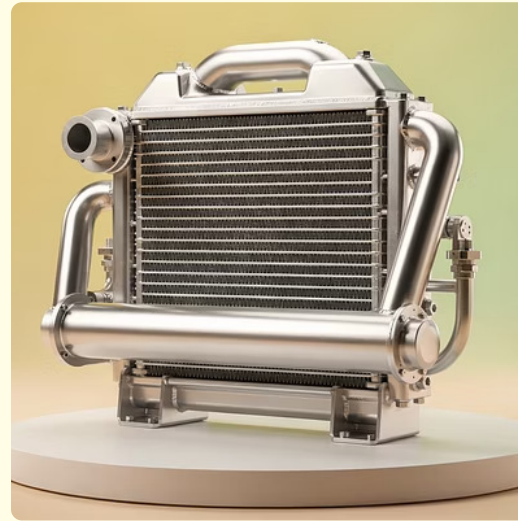
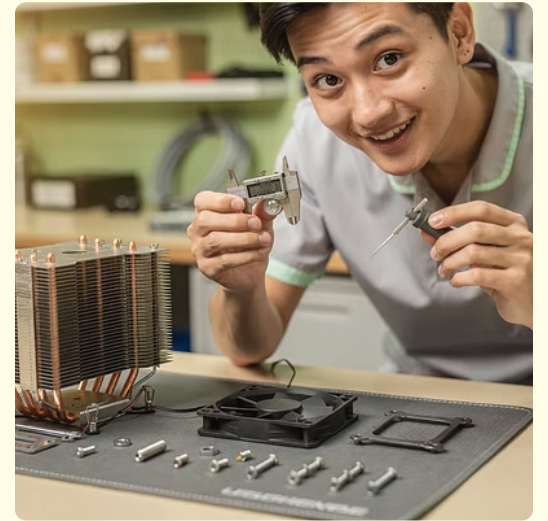
# Air Cooler Cleaning Documentation

Visual documentation of the complete air cooler cleaning process, from initial assessment through final inspection. These images demonstrate the effectiveness of the chemical cleaning procedure and the restored condition of critical cooling components.

The main engine air cooler underwent comprehensive chemical cleaning to remove accumulated deposits, scale, and contaminants that reduce heat transfer efficiency. This preventive maintenance procedure is essential for maintaining optimal engine performance and fuel efficiency.

The cleaning process involved specialized chemical solutions designed to dissolve deposits without damaging cooler components, followed by thorough flushing and inspection procedures.

As per instruction, All inlet and outlet pipe lines removed. Air Cooler opened from place. Air Cooler end covers opened and dismantled. Air cooler lifted and Submersed in chemical Tank using workshop supplied Air cooler cleaning chemical. Chemical circulated in the Air cooler for 06 hours. Then Cooler taken out and High pressure Jet washed thoroughly again and again with fresh water. Air cooler assembled and renewed all Joints. Air cooler boxed back in place. All associated pipe lines fitted back.

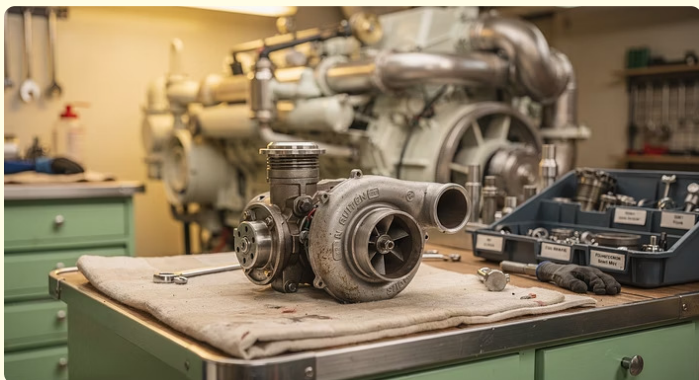
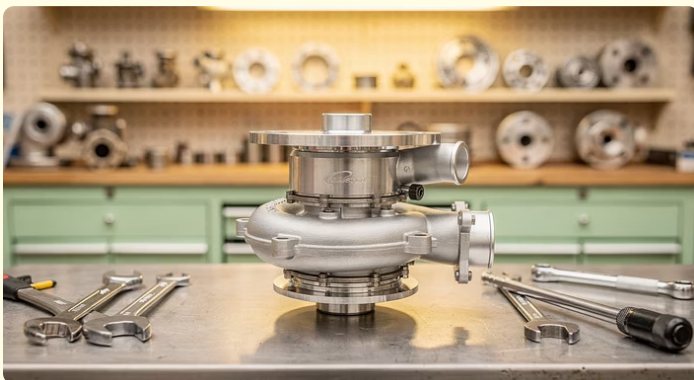
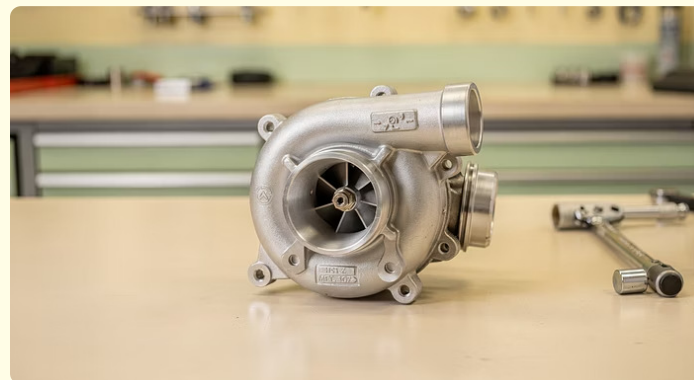
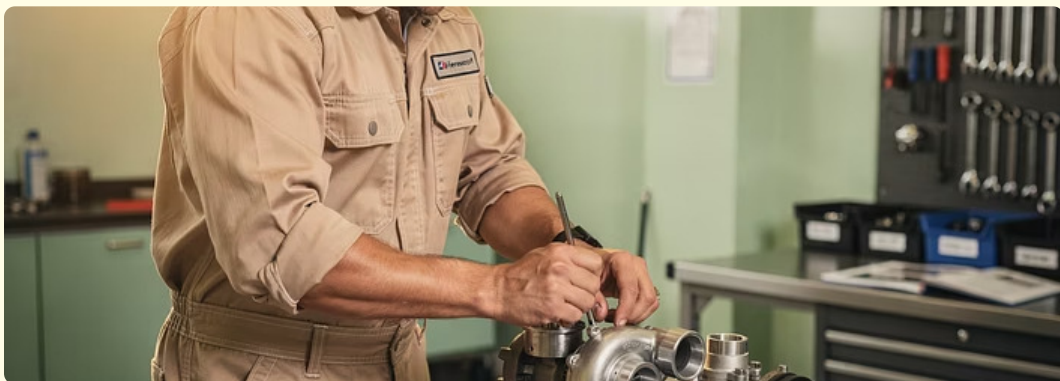
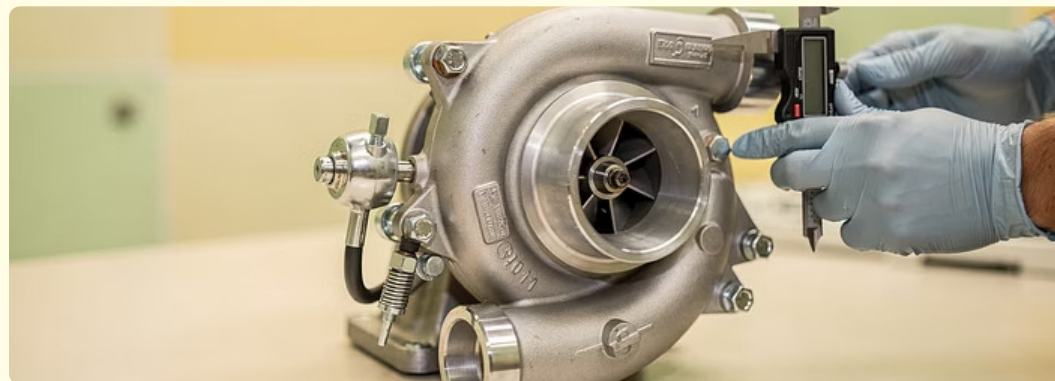
# Turbocharger Service Visual Record

Complete photographic documentation of the turbocharger cartridge replacement operation, capturing each critical stage from removal through final installation and testing.

The turbocharger cartridge replacement represents a critical maintenance intervention to restore engine boost pressure and combustion efficiency. This operation utilized ship-supplied replacement cartridges, ensuring compatibility and immediate availability of spare parts.

The Old Turbocharger suction filter opened, suction housing removed, Turbocharger inner core Turbine and compressor opened and removed from place. Old Nozzle guide removed. Cleaned housing and inspected. New Nozzle guide fitted. New Turbocharge inner core removed from box and checked. New Turbocharger inner core turbine with compressor taken in place and fitted in the housing. New turbocharger assembled back. Engine started and trial taken by shipstaff and found satisfactory.

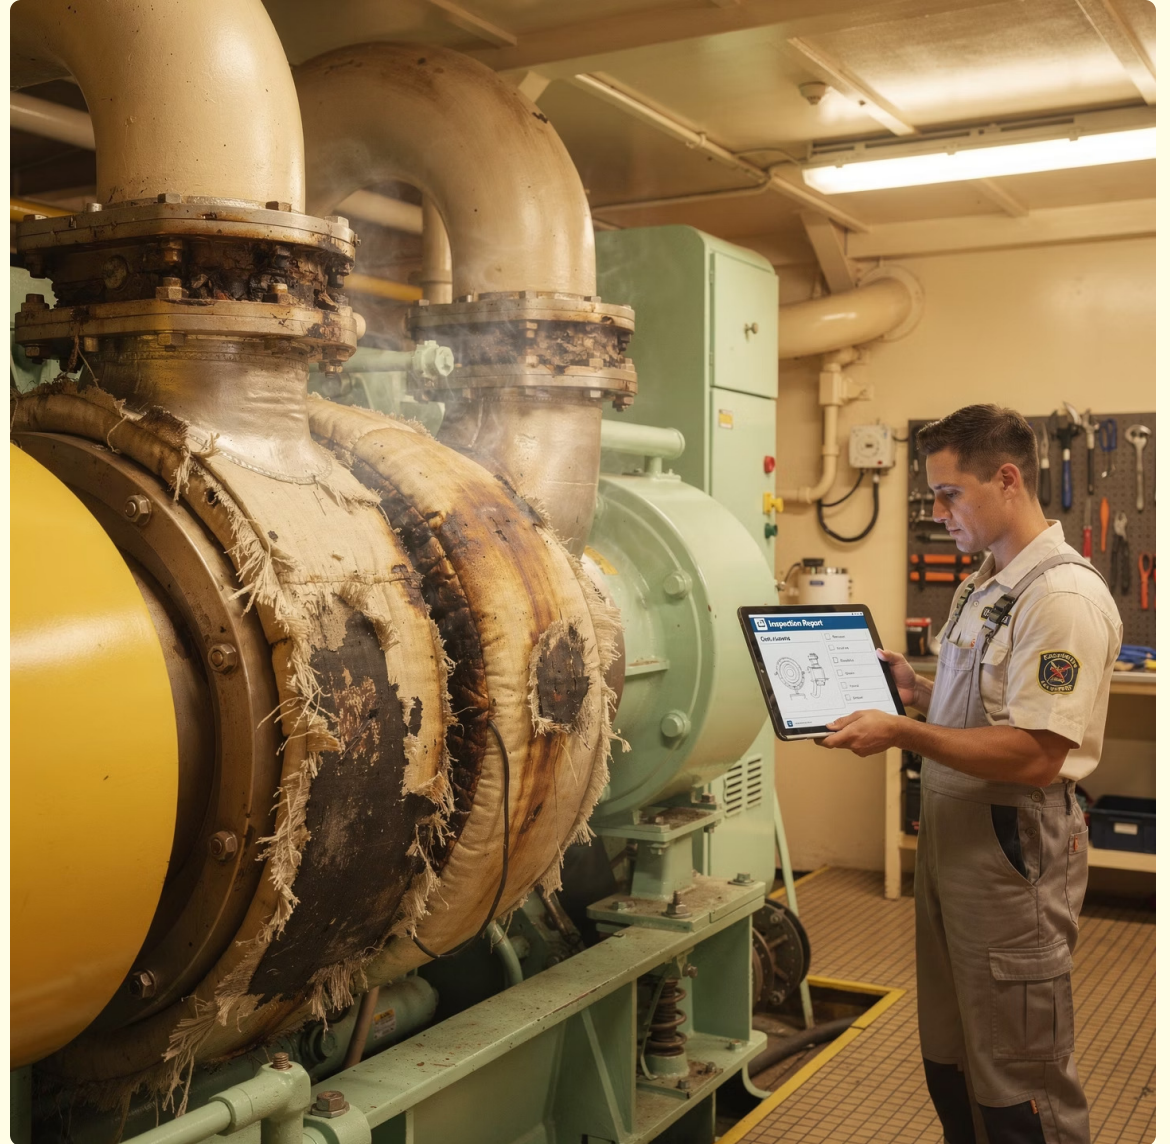
# Bellows Insulation Damage Assessment

Routine inspection revealed deterioration of insulation material on two exhaust bellows units. The damage was characterized by:

- Thermal degradation of outer cladding
- Compression and settling of insulation material
- Exposure of underlying metal surfaces
- Potential heat radiation to adjacent components

Immediate replacement was prioritized to prevent further deterioration and maintain safe operating conditions.

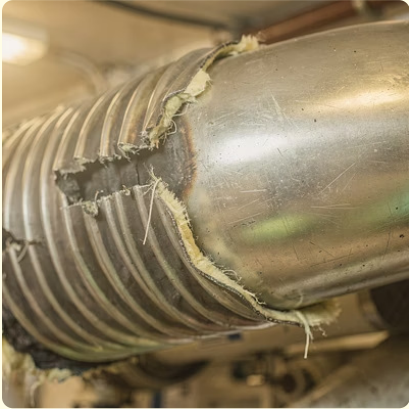
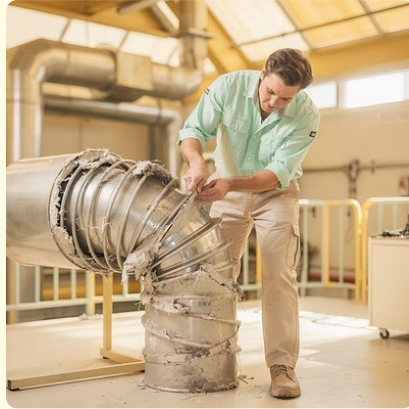
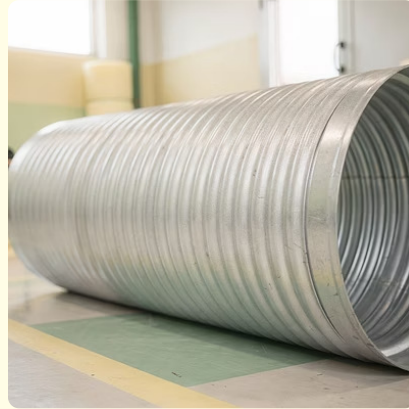
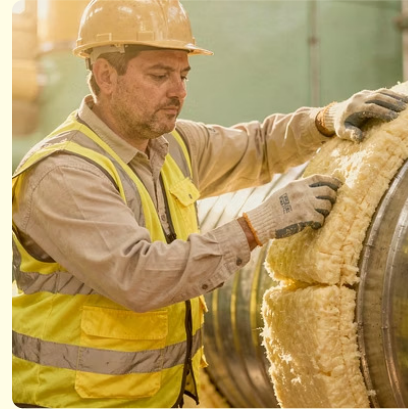
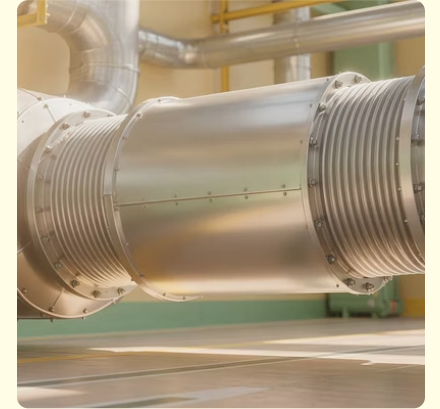
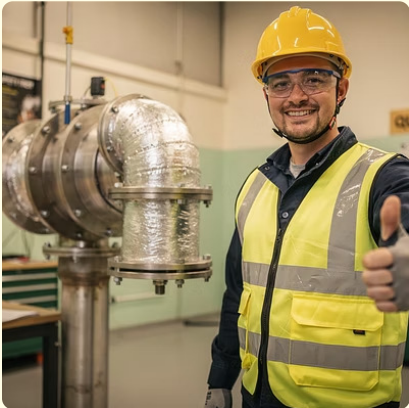
# Exhaust System Repair Documentation

Comprehensive visual documentation of both exhaust bellows insulation replacements, demonstrating the complete repair process from damage assessment through final installation and quality verification.

Old Exhaust lagging removed from Both the Bellows, Found cracks on the bellows. Cold repair carried out using workshop supplied refractory materials. Then hot lagging carried out using Ceramic Blanket/ Fibre cloth & GI sheet. Staging made for Upper bellow to repair.
