## m.v. Despina

### Port Windlass Hydraulic Star Motor & Control Valve — Fitment Report

A detailed account of the inspection, dismantling, overhaul, and successful fitment of the Port Windlass Hydraulic Star Motor and Control Valve carried out across Haldia and Dhamra ports.

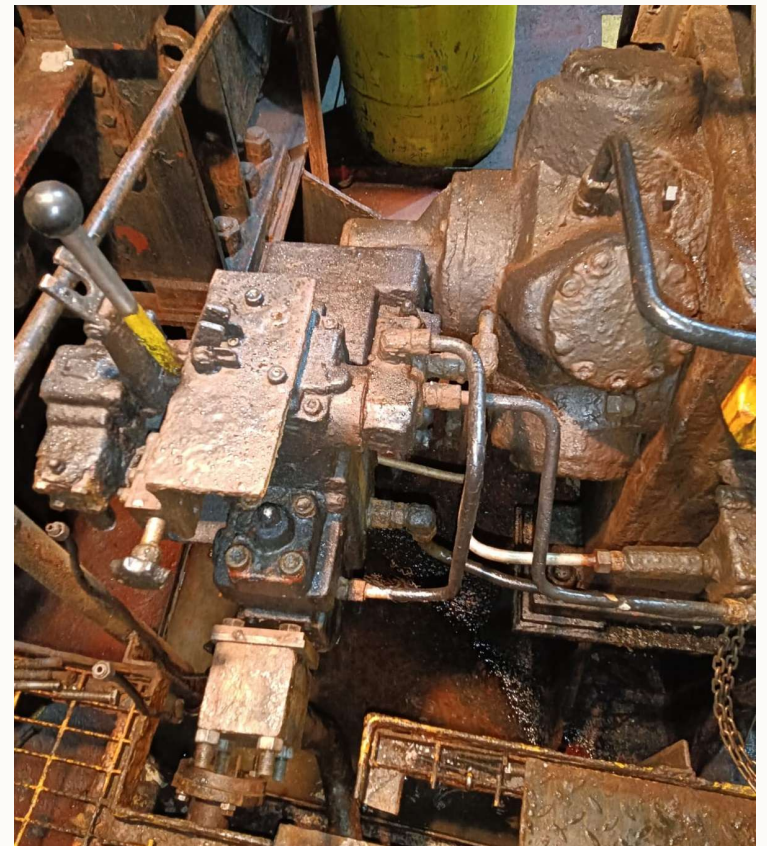
Inspection revealed **heavy leakages** in the Hydraulic Star Motor. Recommendation was made to renew the unit with a new spare Star Motor at the earliest opportunity.

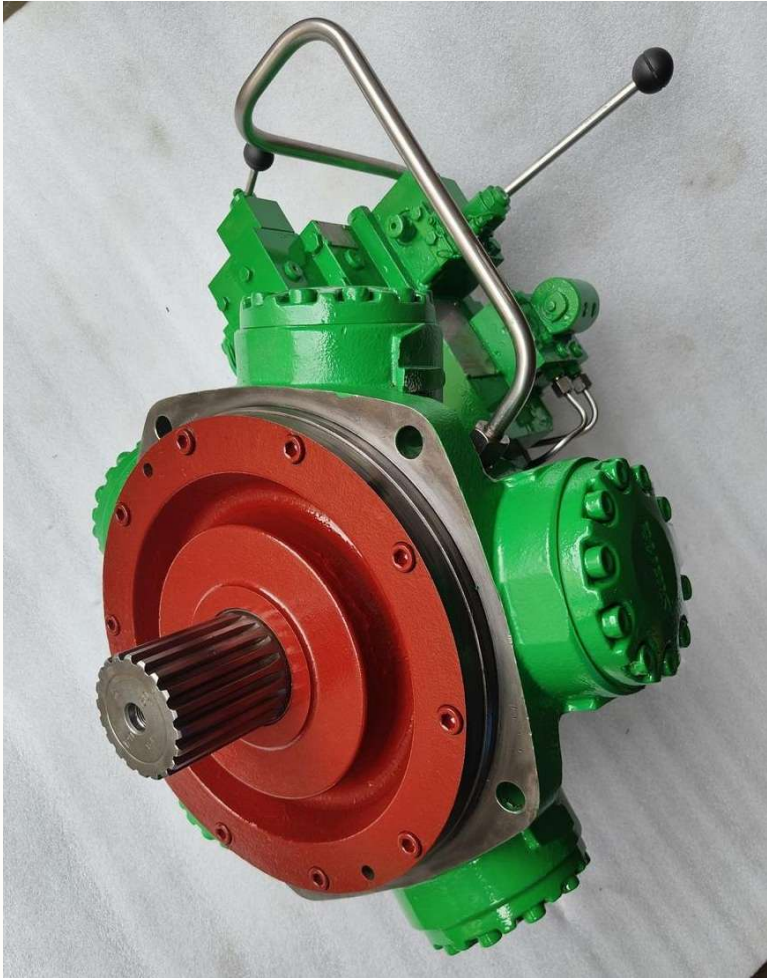
Ship-supplied new Hydraulic Star Motor found **satisfactory** for fitment.

The fitted Control Valve required **modification** for fitment on the Port side.

Agreed with ship staff to fit the New Hyd. Star Motor with the **Old Control Valve** after overhaul.

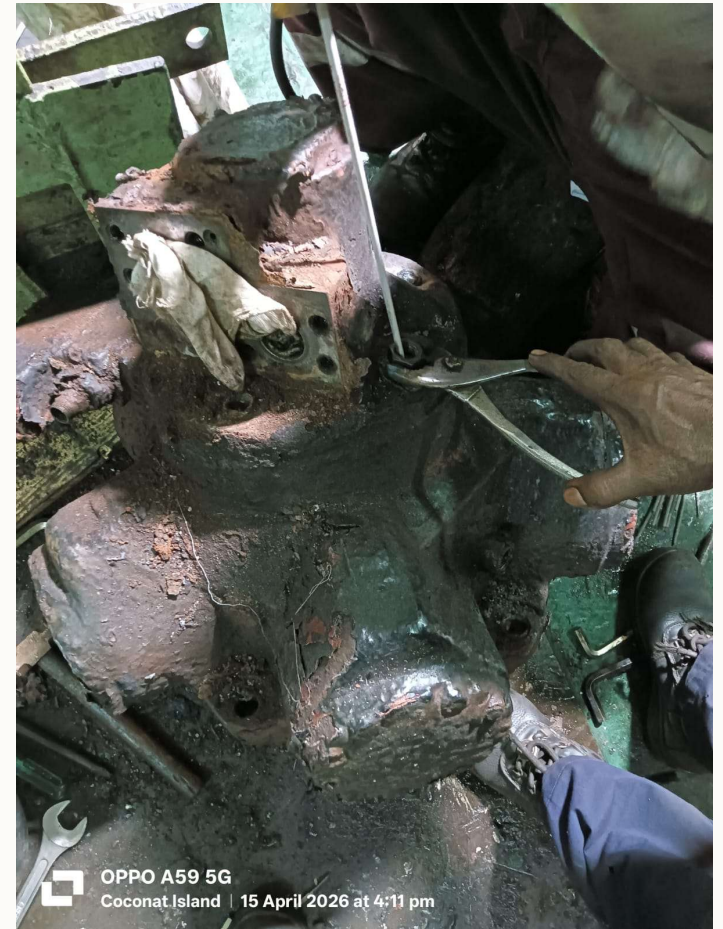
**13 Nos M16 and M18 Allen Bolts** were removed from the body of the Control Valve by welding and heating in the Engine Room.

**6 Nos Allen Bolts** were removed by chisel and hammer on the Port Windlass in position, requiring careful manual effort to avoid damage.

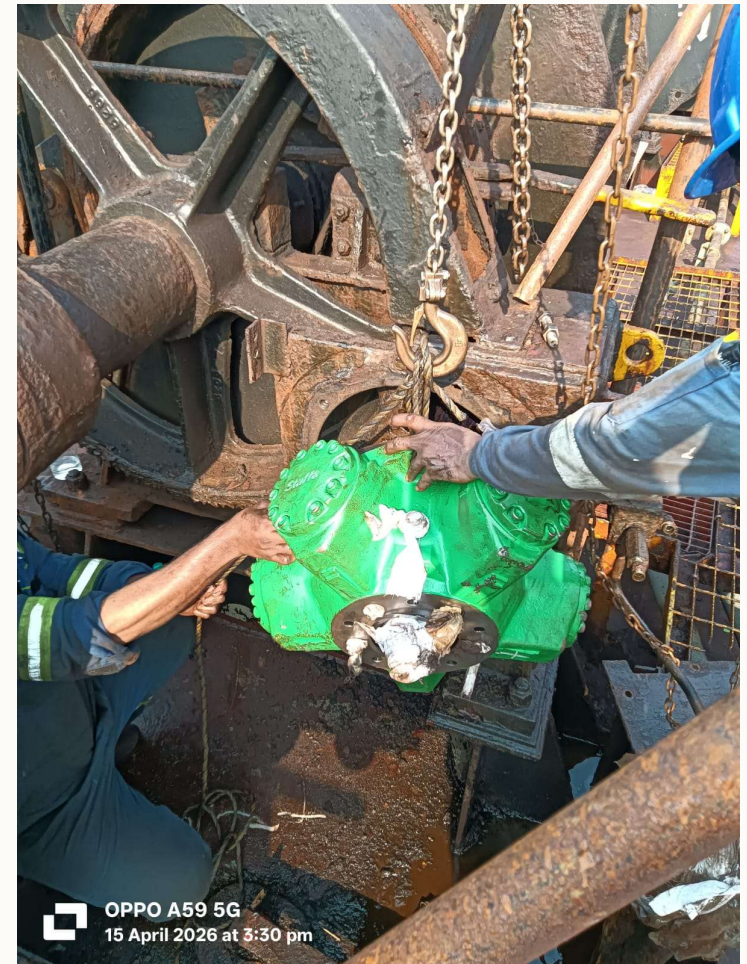
- ⚠ Connecting pipelines were found to be old and rusted – extra precautions were observed during fitment to prevent damage and ensure a leak-free assembly.

The New Hydraulic Star Motor was fitted in place on the Port Windlass foundation. The overhauled Control Valve was then fitted **stage by stage**, with all precautions taken due to the connecting pipelines being old and rusted.

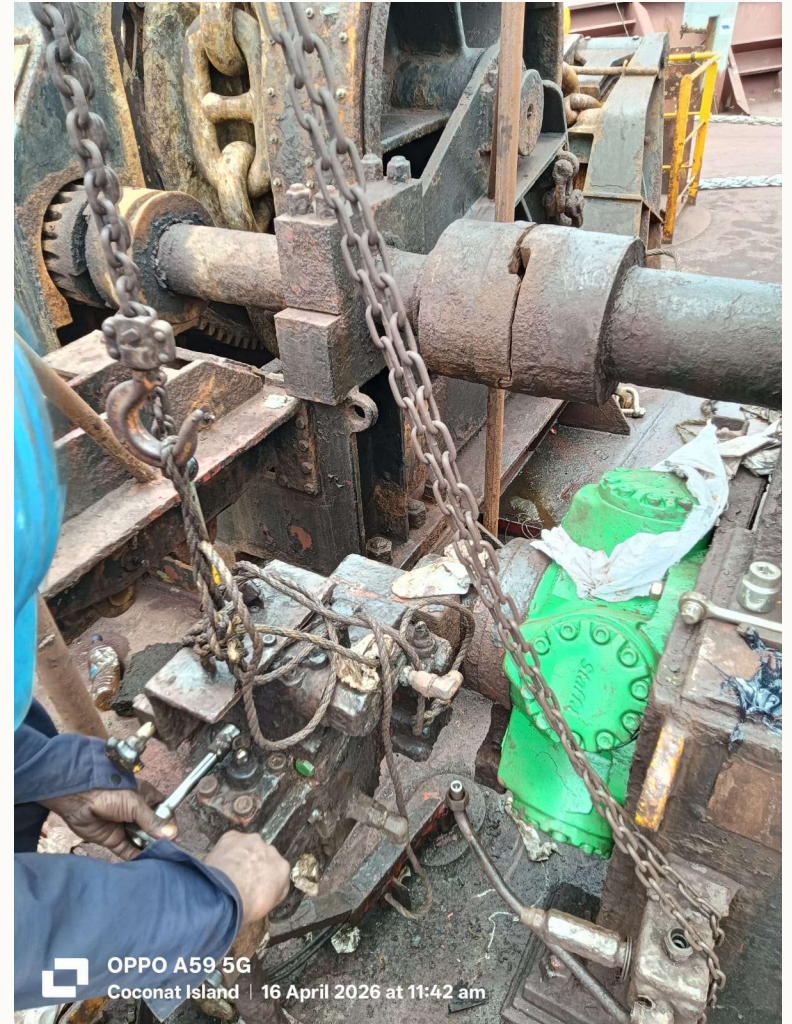
Trial of the Windlass was taken and found **satisfactory with no leakage** observed.

Windlass operation was tried out **many times** — consistently found satisfactory with zero leakages.
