## m.v. Fulmar S — No. 7 Cargo Hold Damage Repair

Port of Haldia | 26 March 2026 – 29 March 2026 | Deck Ref: 2603 / 1157

CLASS BV APPROVED REPAIR

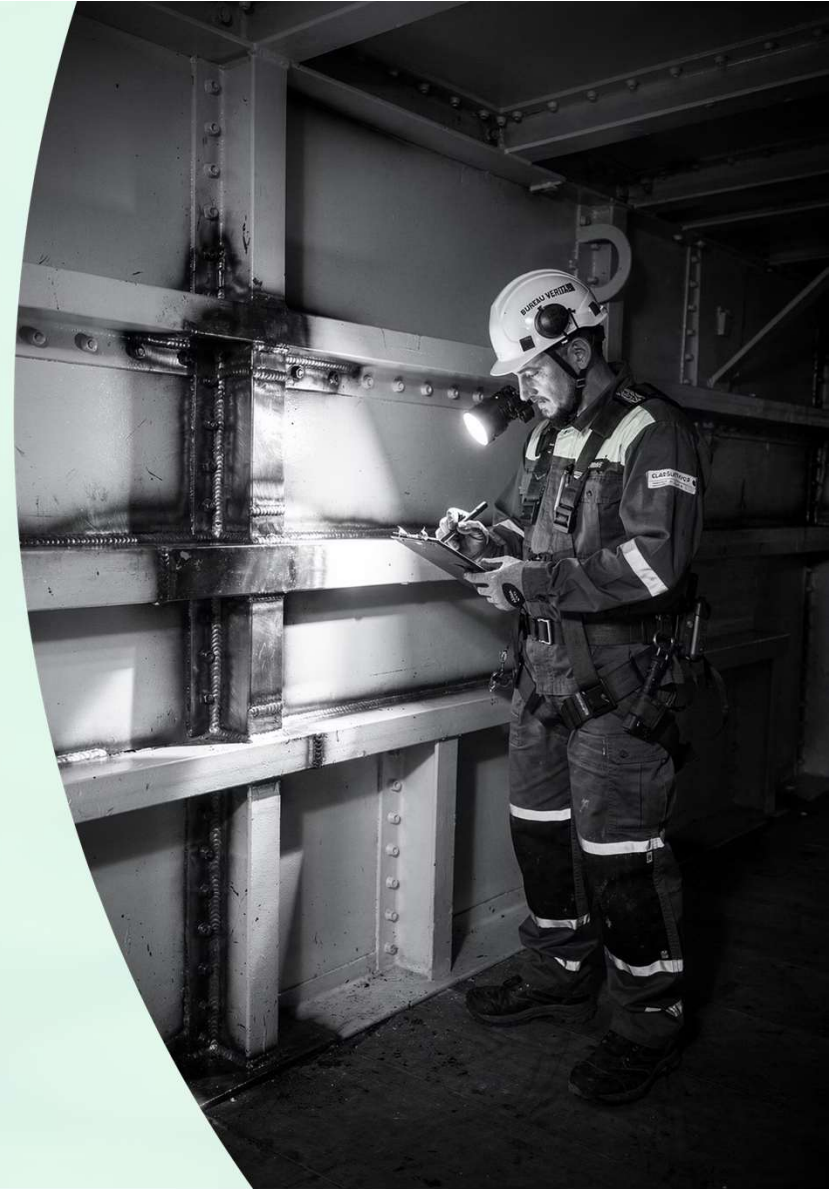
"Checked by Class BV Surveyor and found the repair work satisfactory."

The completed renewal of the hopper plating in No. 7 Cargo Hold was formally accepted by the Bureau Veritas Class Surveyor following inspection. The repair meets all Class standards for structural integrity and watertight integrity.

The No. 7 Cargo Hold hopper plating renewal between Frame Nos. 44-46 was completed fully in accordance with BV Class requirements. The BV Class Surveyor inspected the completed repair and found all work **satisfactory**. All documentation — steel certificates, welder qualifications, and WPS — was submitted to owners, managers, and Class.
