# TMB SHIPPING PVT LTD

## **Various Repair Works done on Pacific International Lines (KOTA Fleet).**

TECHNICAL REPORT

2025-2026

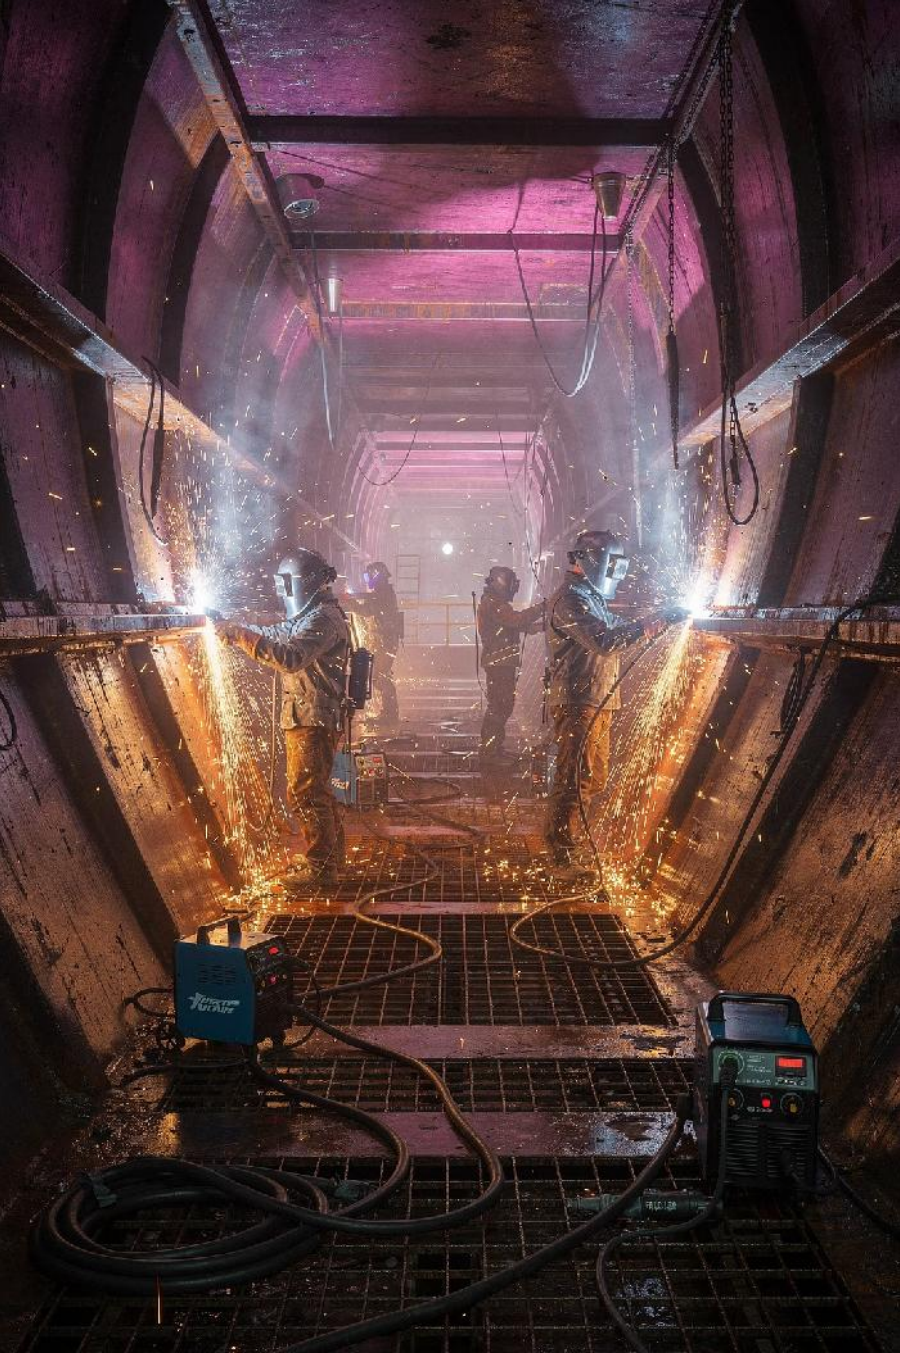
Emergency structural repair performed on m.v. Kota Dahlia, May 20-21, 2025. Ballast tank-top leaking at Bay 21, Row 01 Port required immediate attention to prevent further deterioration and maintain vessel integrity.

## Repair Methodology

Damaged sections removed by gas-cutting and gouging using DA/O<sub>2</sub> gas. New steel doubler plate cut to precise dimensions with V-weld preparations. Multi-run electric welding using low hydrogen electrodes ensured structural integrity.

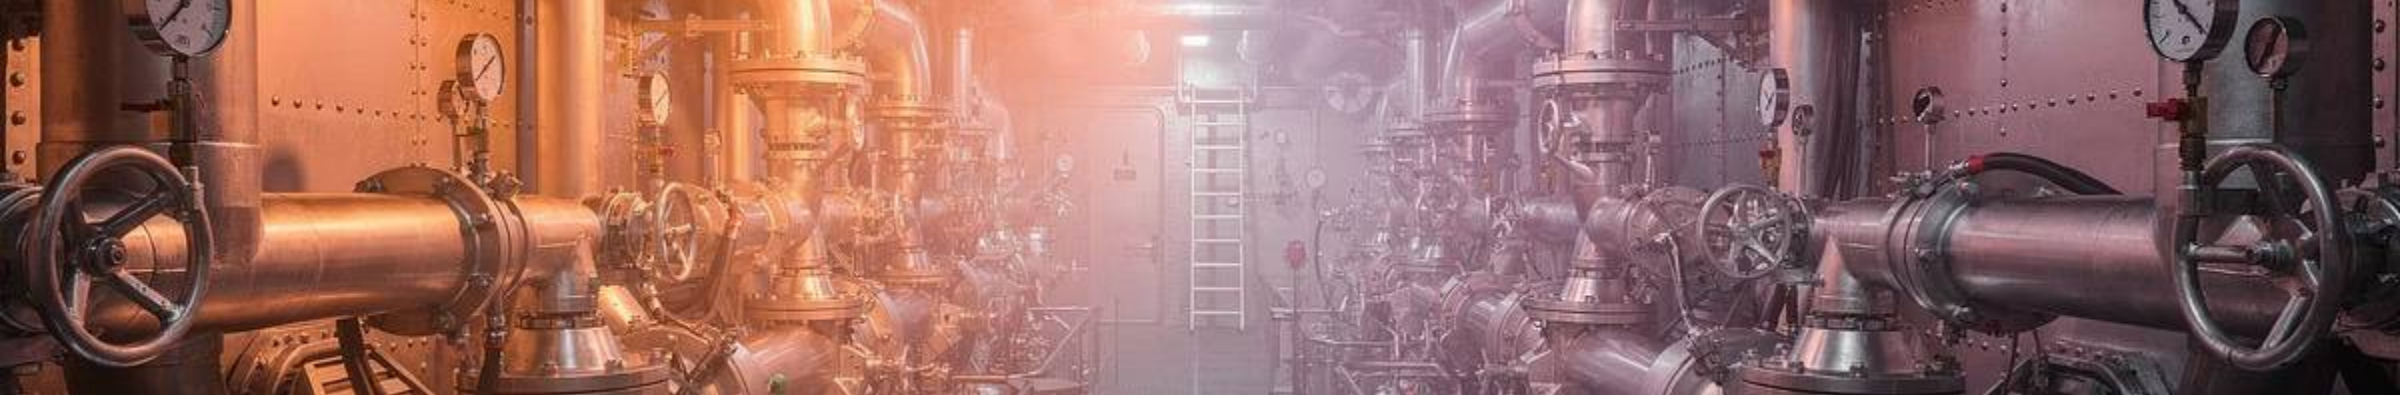
Complex pipeline renewal project on m.v. Kota Dahlia, December 2-4, 2025. Three damaged main engine seawater cooling pipelines required complete replacement in confined under-floor spaces with limited access.

Damaged 6" diameter pipelines removed in sections. One 1000mm in-way pipeline removed for access

Three new pipelines fitted with bends, flanges, bolts/nuts. All joints vulcanized and pressure tested

All three pipelines fabricated using MS seamless schedule-80 pipe, 6" diameter, with various configurations to match the main engine cooling system requirements.

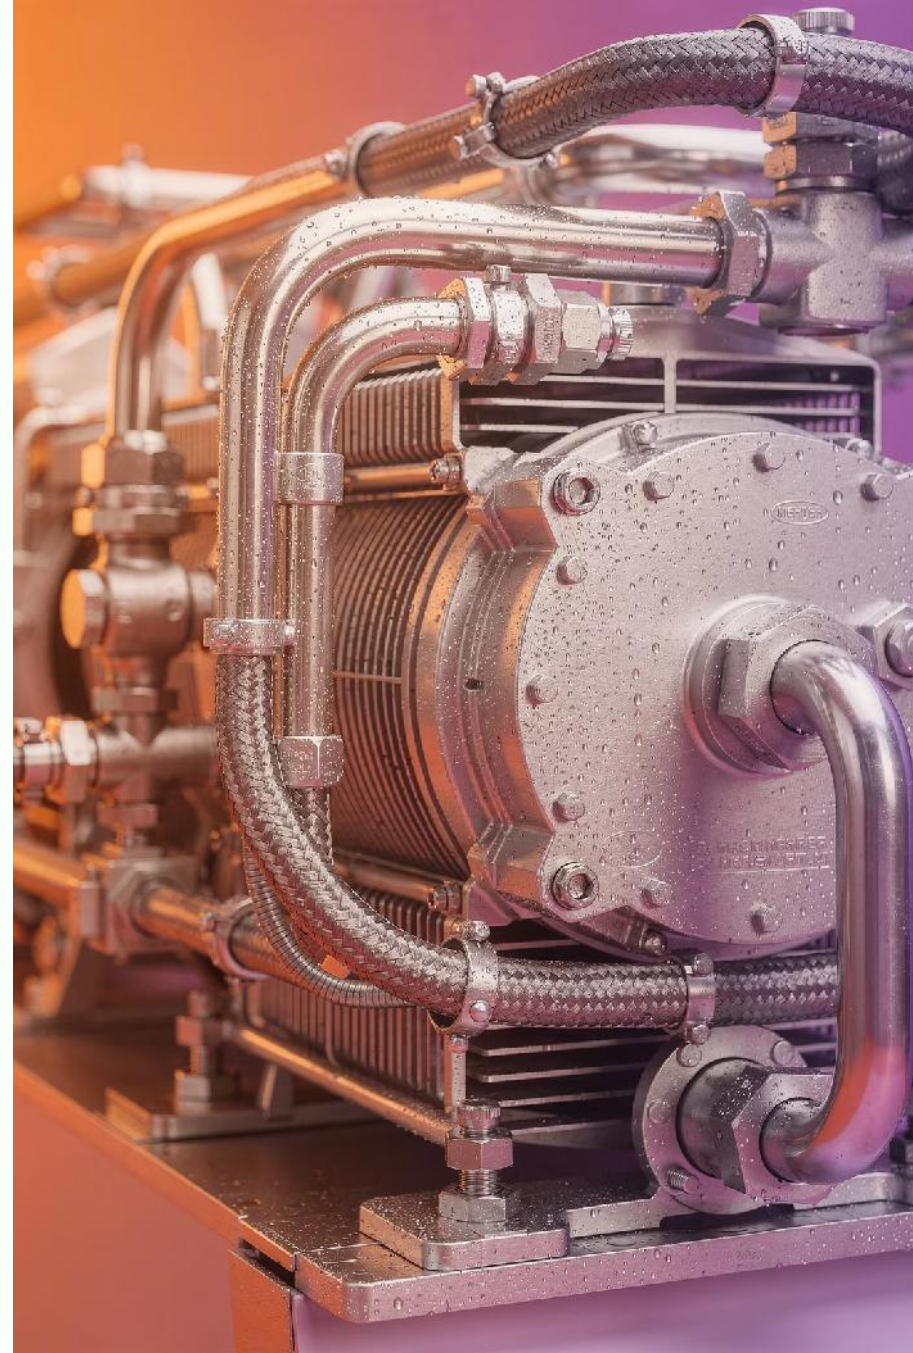
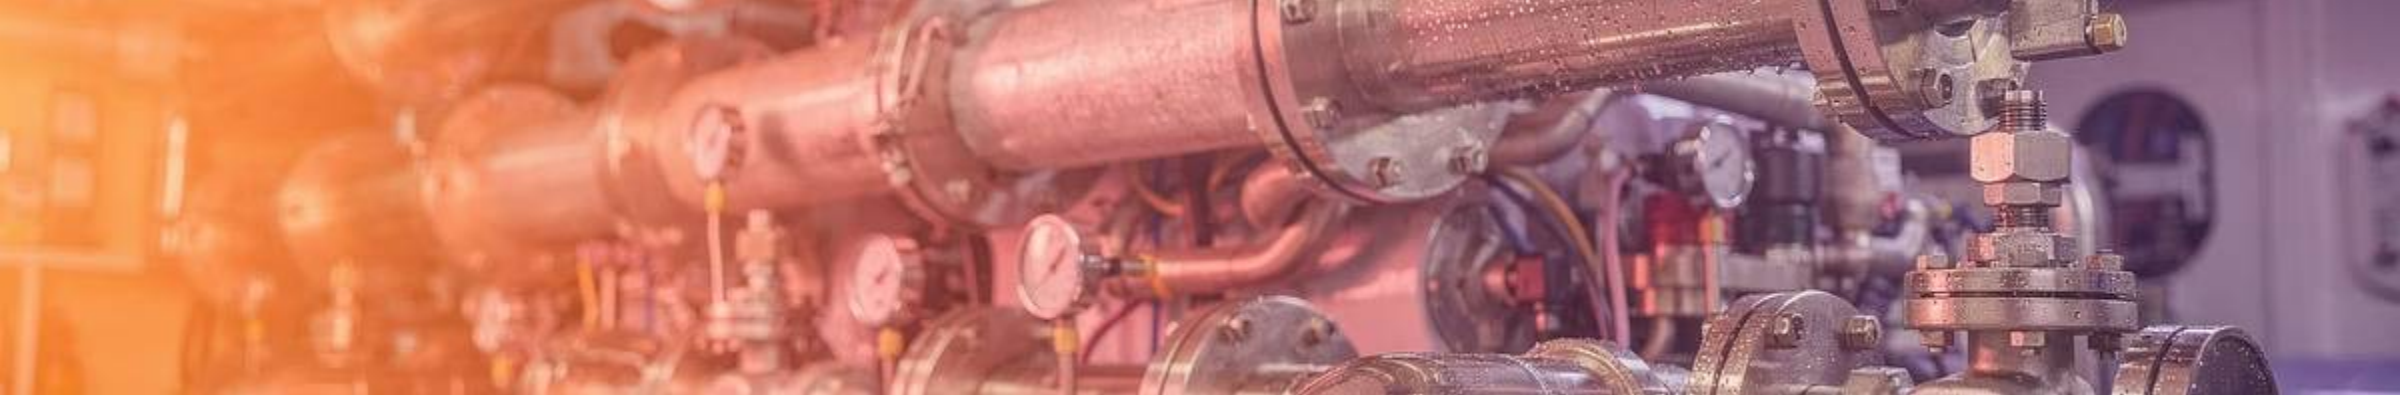
# **m.v. Kota Duta Cooling System Overhaul**

Dual pipeline renewal project completed November 26-27, 2025. Both main engine seawater cooling outlet pipelines and auxiliary engine seawater cooling inlet pipelines showed critical damage requiring immediate replacement.

AE seawater cooling inlet pipelines replaced with new materials. All connections fitted with HT bolts/nuts and new gaskets to prevent future leakage and ensure reliable operation.

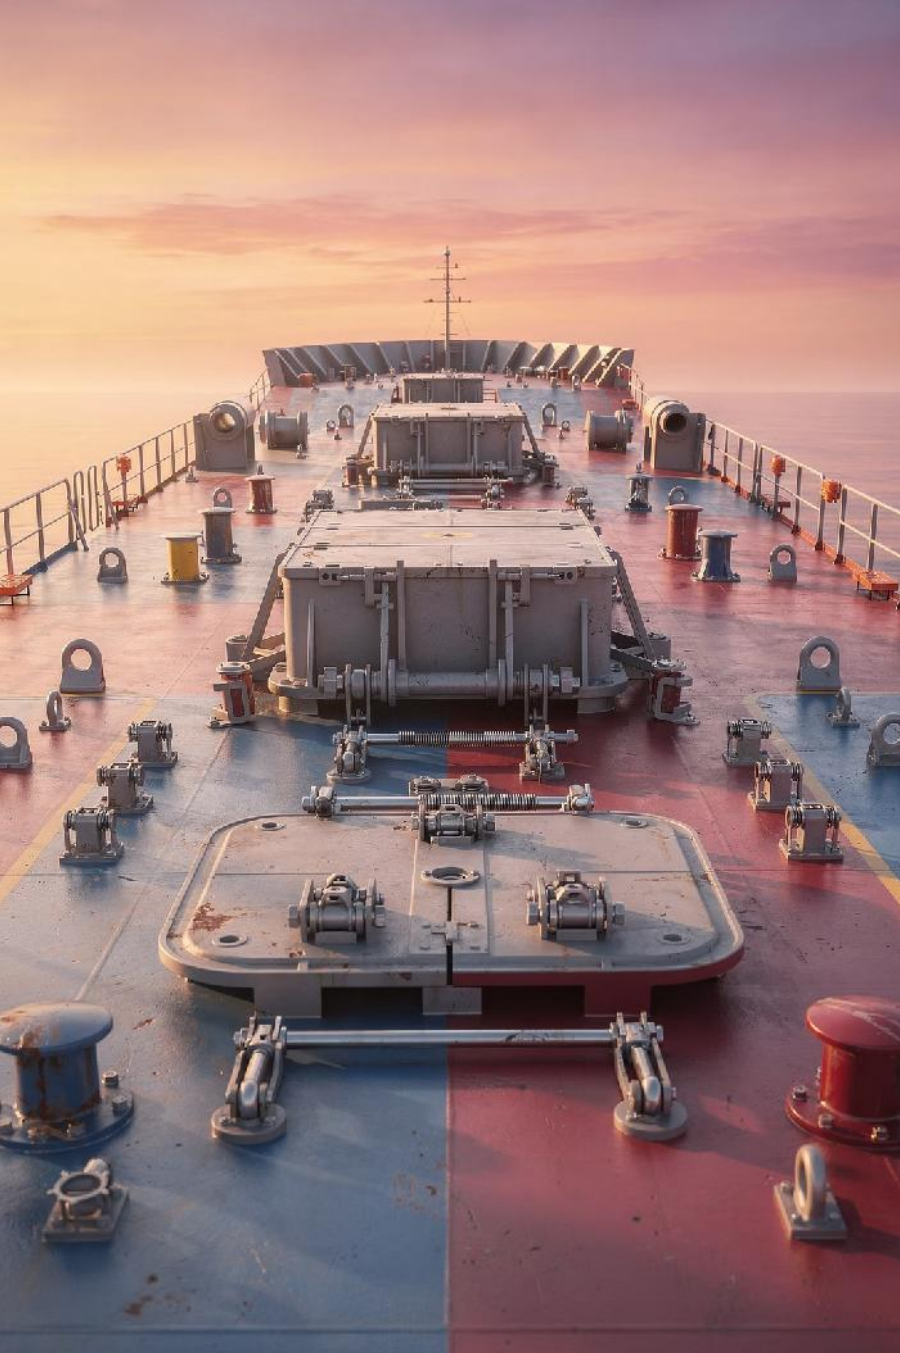
# Hatch Cover & Pontoon Repairs

Comprehensive structural repairs completed June 14-16, 2025. Multiple components of hatch covers and pontoons required renewal to maintain watertight integrity and cargo security.

Damaged fashion plates cropped and renewed on hatch covers and pontoons to restore structural integrity

Worn lashing bar I-pads replaced to ensure secure container fastening during transit

Damaged ISO sockets cropped and renewed for proper container twist-lock engagement

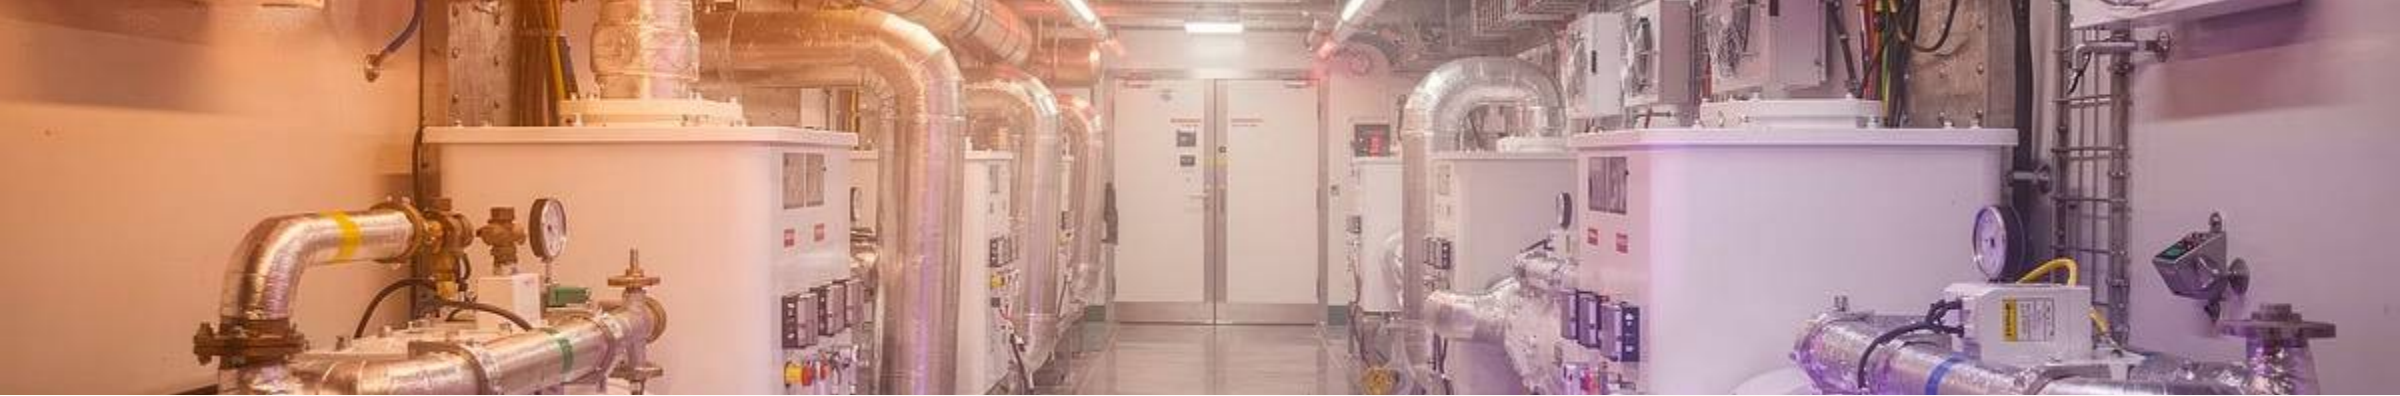
## A.C. System Pressure Testing Protocol

Leak detected at condenser sight-glass, repaired and rectified. System rechecked - no leaks detected

System charged with nitrogen gas (high side and low side including compressor) to check for leakage

After nitrogen release, system vacuumized using workshop-supplied vacuum pump to -30. Vacuum held satisfactorily for hours, confirming complete system integrity and absence of leaks.

Fresh R404A refrigerant (ship-supplied) charged into system. Main A.C. system recommissioned successfully. Cooling found in order with no frosting or icing noted.
