# M.V. FENGHAI 66

## Maintenance Report

Comprehensive maintenance operations conducted at NSD, Kolkata during the period of January 7-8, 2026. This report documents critical engine room repairs and system upgrades performed to ensure optimal vessel performance and safety compliance.

# TMB SHIPPING PVT LTD

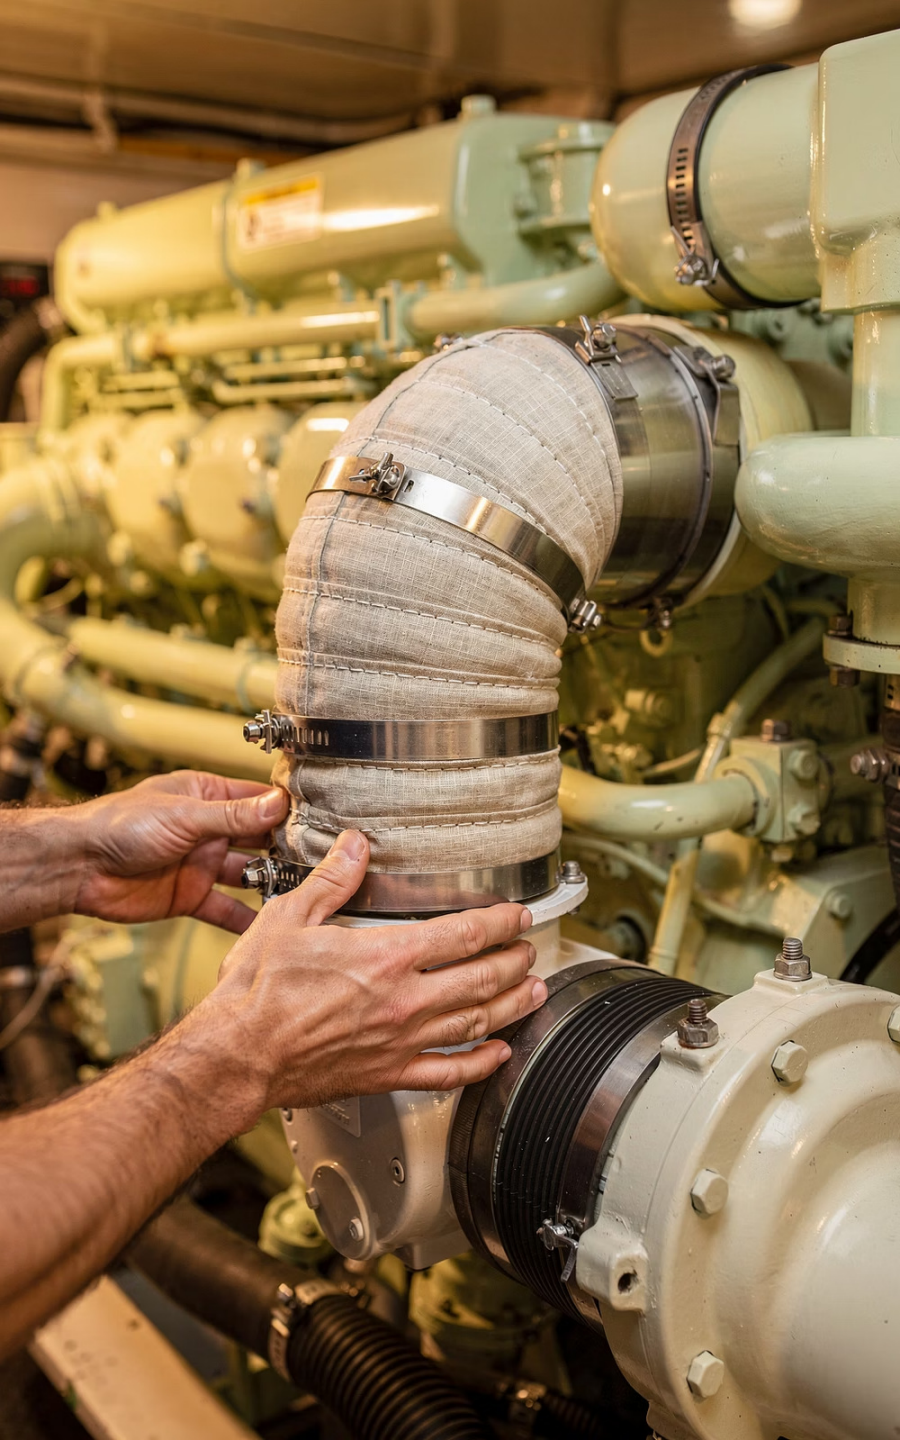
Routine inspection revealed deterioration of insulation material on two exhaust bellows units. The damage was characterized by:

- Thermal degradation of outer cladding
- Compression and settling of insulation material
- Exposure of underlying metal surfaces
- Potential heat radiation to adjacent components

Careful removal of deteriorated insulation material while protecting bellows integrity and documenting damage extent.

Thorough cleaning of bellows surfaces, removal of residual insulation material, and inspection for underlying damage.

Installation of stainless steel cladding to protect insulation from mechanical damage and environmental exposure.
