## m.v. Despina

### Port Windlass Hydraulic Star Motor & Control Valve — Fitment Report

A detailed account of the inspection, dismantling, overhaul, and successful fitment of the Port Windlass Hydraulic Star Motor and Control Valve carried out across Haldia and Dhamra ports.

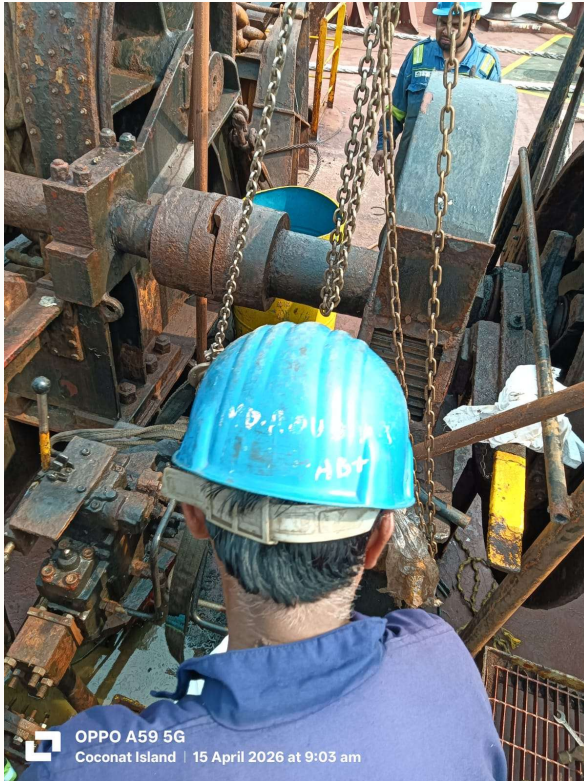
Ship-supplied new Hydraulic Star Motor found **satisfactory** for fitment.

Agreed with ship staff to fit the New Hyd. Star Motor with the **Old Control Valve** after overhaul.

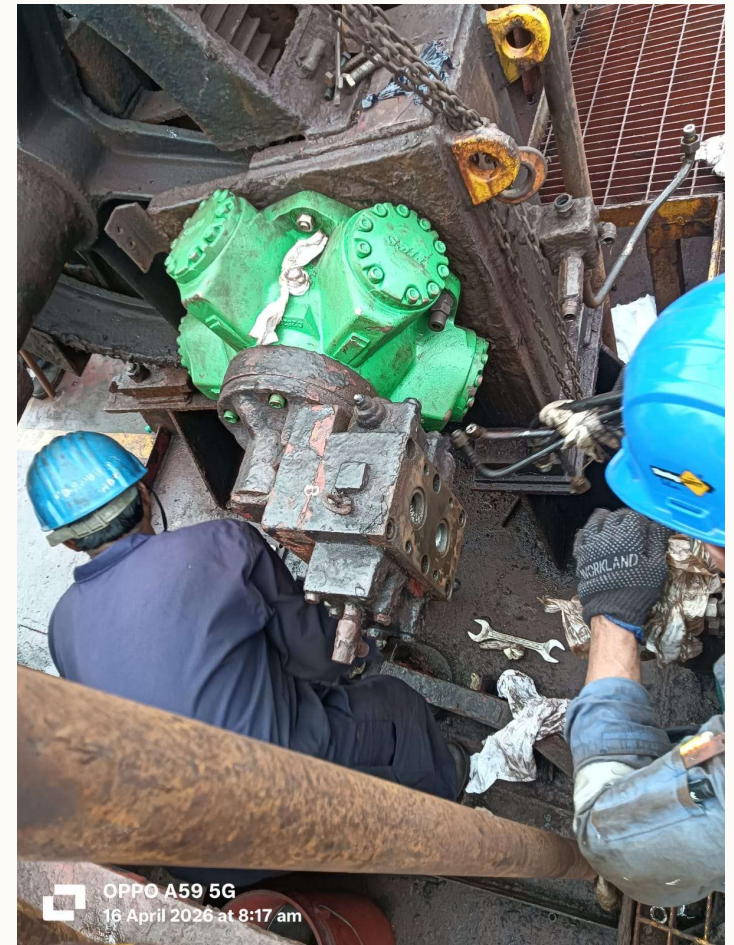
Satisfactory – No leakage, full operational capability restored
